MICROSCOPIC EXAMINATION OF STEEL

HENRY FAY, Ph. D., D. Sc.

*Professor of Analytical Chemistry, Massachusetts Institute of Technology
Consulting Metallurgist, Watertown Arsenal*

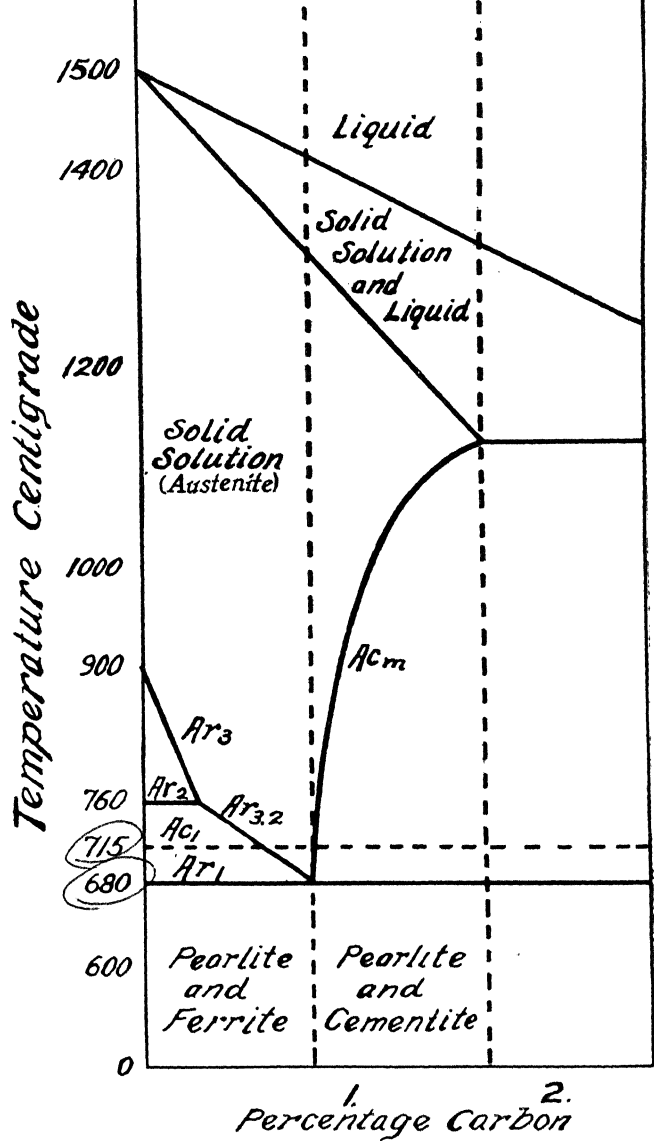
Fig. 1

Portion of iron-carbon diagram

constituents, iron and iron carbide. The Ac_1 point is approximately 30° higher than the Ar_1 point, and represents the beginning of the formation of solid solution. In steels containing 0.85 per cent carbon there is but one critical temperature at which the solid solution decomposes into its constituents, iron and iron carbide. This is known as an eutectoid steel, and its microscopic constituent is pearlite. Pearlite always etches dark, and under high magnifications is shown to consist of alternate laminations of iron and iron carbide. Steels containing less than 0.85 per cent carbon are hypoeutectoid, and contain the microscopic constituents ferrite and pearlite, the amount of the latter increasing with the per cent of carbon. Steels containing more than 0.85 per cent carbon are hypereutectoid, and contain the microscopic constituents cementite (iron carbide, Fe_3C) and pearlite. These facts are illustrated in the diagram. (Fig. 1.)

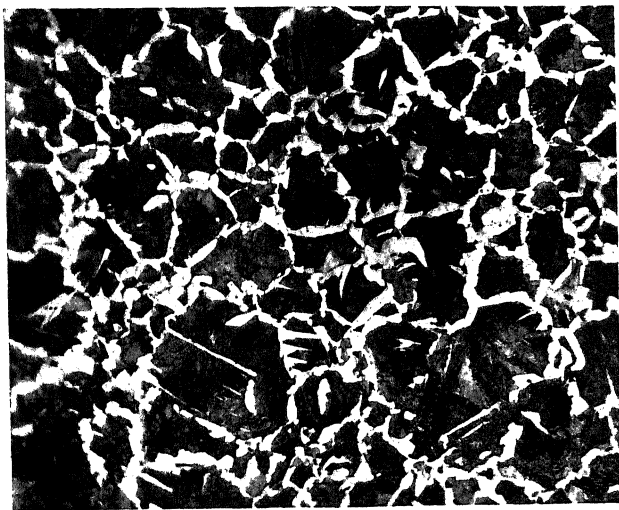
PHOTOGRAPH NO. 4. X75.

0.49% carbon. Ferrite (white) and pearlite (dark).

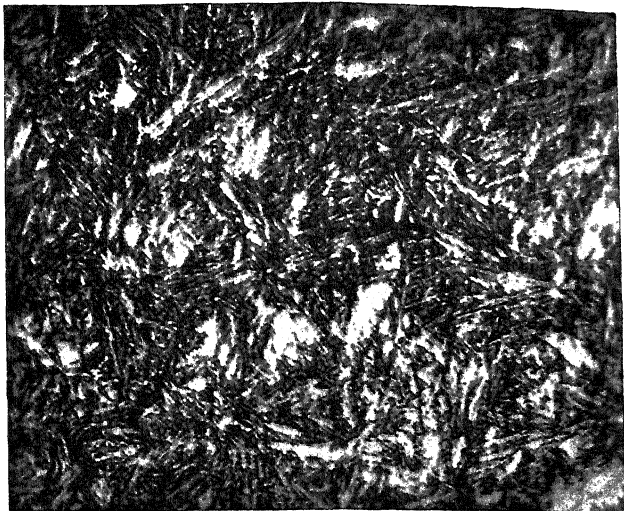
PHOTOGRAPH NO. 34. X500.

Microstructure of forging which had been originally martensitic, and in tempering this structure has not been completely eliminated.

observed that the original martensitic structure is completely removed by the tempering process. This point is illustrated by photograph No. 34 in which there are distinct remains of the original martensitic structure. Such a steel properly heat treated ought to show a structure similar to photographs Nos. 12 or 13.

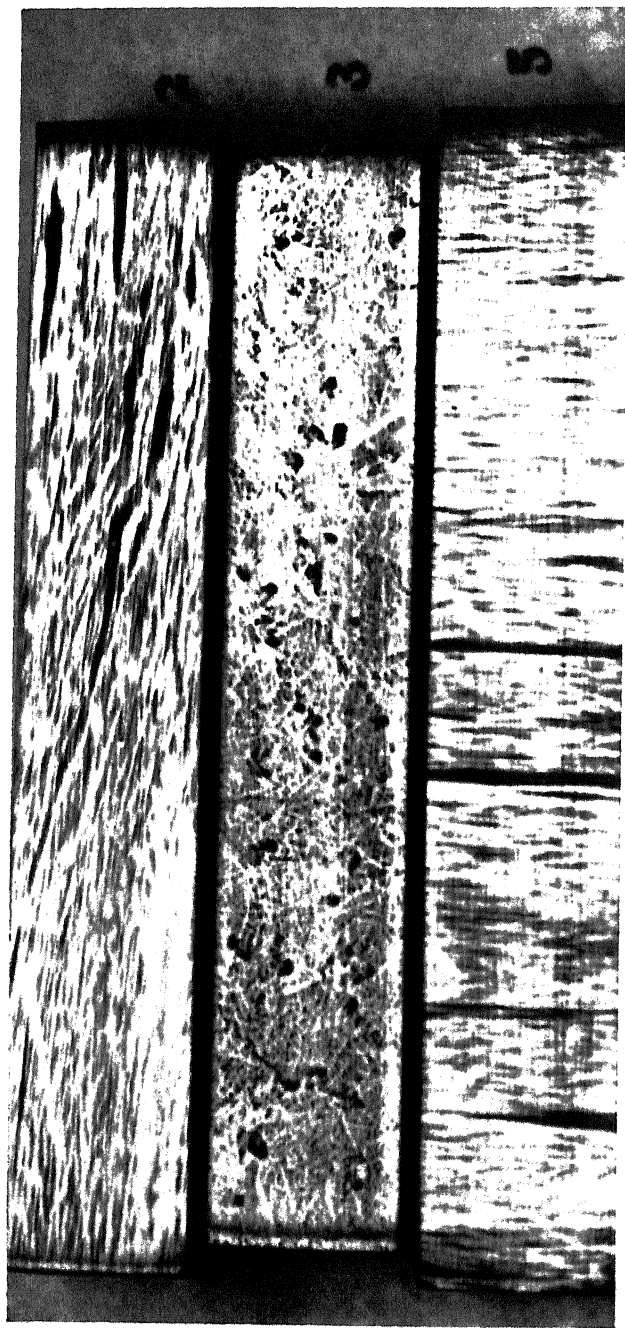
PHOTOGRAPH NO. 38.

Macrostructure of test bars of 10-inch pipe showing surfaces cut longitudinal 5, radial 3, and tangential 2 to axis.

Photographs Nos. 38 and 39 show the macrostructure of the steel when etched with iodine, the specimens shown in photograph No. 38 being taken longitudinally, radially, and circumferentially. The segregation of phosphorus is indicated by dark lines in pieces Nos. 2 and 5 of photograph No. 38 and in pieces 3 and 4 of photograph No. 39 and by the dark spots in piece 3. Photograph No. 39 shows the metal cut from the region of the fracture and treated in the same manner, as shown in piece marked 5 in photograph No. 38, and in other pieces not shown. The dark streaks were found to be elongated parallel to the direction of forging, and it is reasonable to assume that the elongation will always be parallel to the surface of the metal forged. By inspection of the two larger pieces of metal from the region of the crack (photograph No. 39) it will be seen that there is considerable distortion of the phosphide area

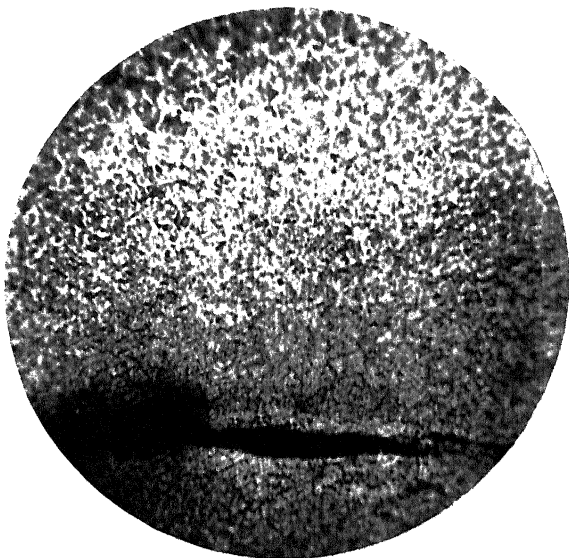
PHOTOGRAPH NO. 40. X50.

Crack and slag, with decarbonized area in 10-inch rifle.

Examination of sections in the vicinity of the crack showed many fine cracks, slag inclusions, and carbonless areas. The cracks led to slag, and where the slag was found there were also found decarbonized areas. Photograph No. 40 shows a crack ending in slag and surrounded by decarbonized iron. The course of the slag was quite irregular, as shown in photographs Nos. 41 and 42.
